M&H Electric Fabricators, Inc.  
13537 Alondra Blvd.  
Santa Fe Springs, CA 90670  
Phone: (562) 926-9552  
Fax: (562) 926-9572

## TRANSISTOR IGNITION PERFORMANCE MODULE

The TI Plus Performance Module is a drop-in replacement and upgrade for the electronics used in the original TI Ignition Pulse Amplifier. This easily installed Module fits completely inside the stock housing and does not require any changes to the wiring or the amplifier. The result is an *"eco-friendly state of the art ignition technology with an absolutely stock appearance"*. Here are some of the advantages of this module:

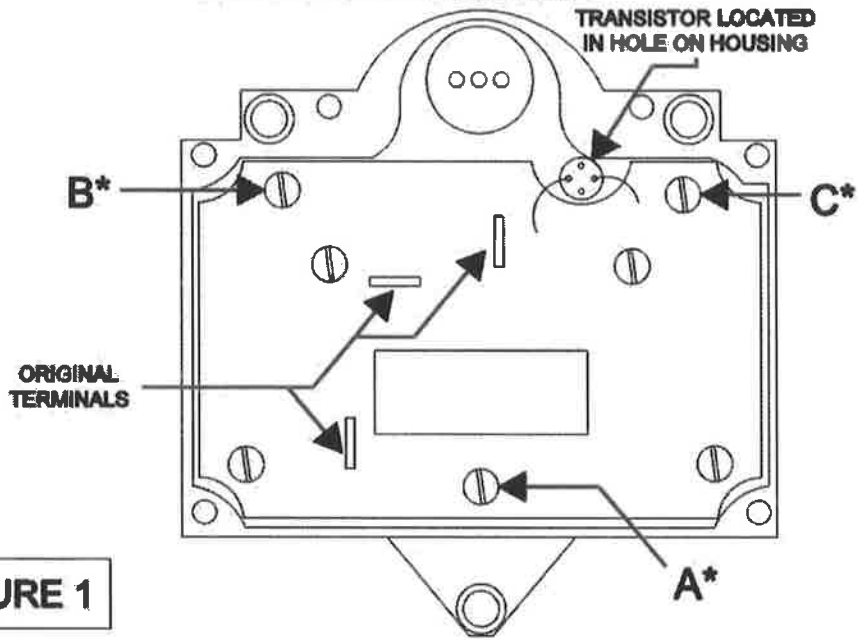
**FIGURE 1**

**BACK VIEW OF T.I. AMPLIFIER  
WITH BACK COVER REMOVED**

2. Disconnect battery ground cable before working on the system. It may be necessary to reconnect battery ground cable for certain diagnostic procedures and is left to the installer's discretion. Remove the amplifier and turn it around to the back cover. Remove the six (6) screws holding on the back cover to the Amplifier housing and carefully lift it off, exposing the internal circuit board (Figure #1). Use caution to avoid damaging the gasket on the underside of the cover.

3. Remove the three (3) screws (indicated in Figure #1 by A\*, B\*, C\*) holding down the existing circuit board. Remove the three (3) wires and terminals from the circuit board. Remove the old circuit board from the amplifier housing and small transistor located in a recessed hole in the housing near screw hole "C" in Figure #1. Also remove the small divider plate located in the recessed hole where the transistor was removed. Make sure the inside of the Amplifier housing is clean, free of dirt, grease, or obstructions such as casting flash that interferes with the new module installation. If the internal surface of the housing is corroded, it is advisable that the inside of the housing be glass beaded.

4. Place the new module in the amplifier housing, line up the three (3) holes (indicated in Figure #1 by A\*, B\*, C\*), and secure in place with the same three screws that held the old circuit board.
